ENVIROVUE HOME INSPECTION
POWERED BY INFRARED TECHNOLOGY

Sample
123 Sample Lane
Sample City, CA 94010

Date of Inspection: 6/23/2008

PROPERTY INSPECTION REPORT

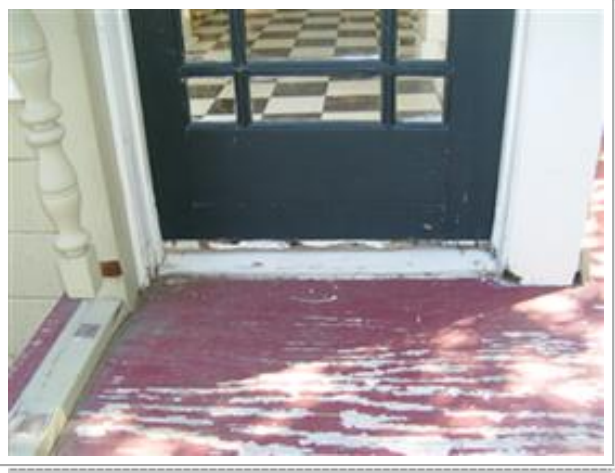
Figure Number 1

3. DETERIORATED EXTERIOR DOOR. LOCATION: SIDE ENTRY DOOR LEFT. I observed a damaged and deteriorated exterior at the aforementioned location. The implications of damaged and deteriorated exterior doors are: may be unable to stop intruders; allow moisture to enter building, draft; may not open and close properly (fire safety). RECOMMENDATION: REPAIR, REPLACE SERVICING (See Figure #1)

1. DETERIORATED EXTERIOR DOOR. LOCATION: SIDE ENTRY DOOR LEFT. I observed a damaged and deteriorated exterior at the aforementioned location. The implications of damaged and deteriorated exterior doors are: may be unable to stop intruders; allow moisture to enter building, draft; may not open and close properly (fire safety). RECOMMENDATION: REPAIR, REPLACE SERVICING (See Figure #1)

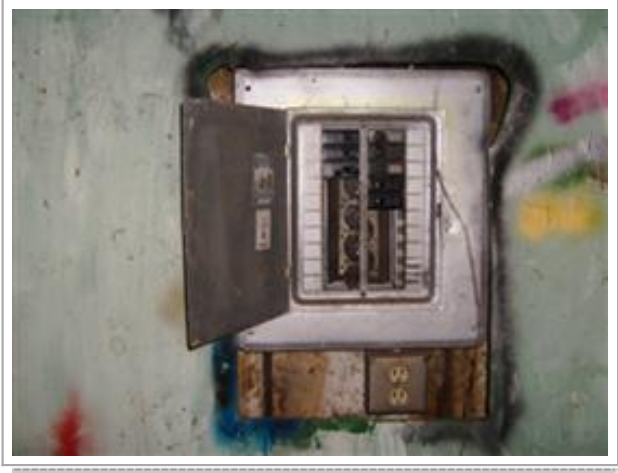
Figure Number 2

5. REPAIR PANEL COVER. One or more electrical panel covers are deteriorated, missing, or damaged. The exterior cover helps keep the electrical components dry when they would otherwise be exposed to weather. Damaged or missing covers increase the rate at which the components will deteriorate and may present a hazard if components get wet. RECOMMENDATION: SAFETY ISSUE (See Figure #2)

1. REPAIR PANEL COVER. One or more electrical panel covers are deteriorated, missing, or damaged. The exterior cover helps keep the electrical components dry when they would otherwise be exposed to weather. Damaged or missing covers increase the rate at which the components will deteriorate and may present a hazard if components get wet. RECOMMENDATION: SAFETY ISSUE (See Figure #2)

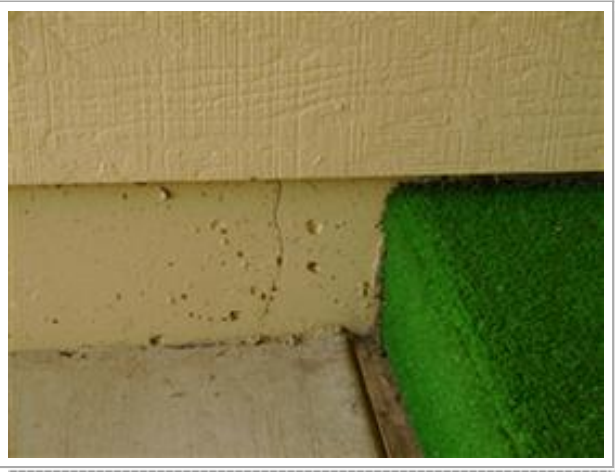
Figure Number 3

2. **VERTICAL FOUNDATION CRACK(S).** I observed vertical cracks in the foundation wall in various locations. These types of foundation cracks are usually of no concern. However, it is impossible to ascertain building movement, recency of foundations cracks, active or historical movement of these cracks in a one time home inspection. A specialist using a sophisticated measuring protocol can provide you with this information if you so desire. If the cracks widen or lengthen, it is our recommendation that you seek further advice from a specialist. (See Figure #3)

1. VERTICAL FOUNDATION CRACK(S). I observed vertical cracks in the foundation wall in various locations. These types of foundation cracks are usually of no concern. However, it is impossible to ascertain building movement, recency of foundations cracks, active or historical movement of these cracks in a one time home inspection. A specialist using a sophisticated measuring protocol can provide you with this information if you so desire. If the cracks widen or lengthen, it is our recommendation that you seek further advice from a specialist. (See Figure #3)

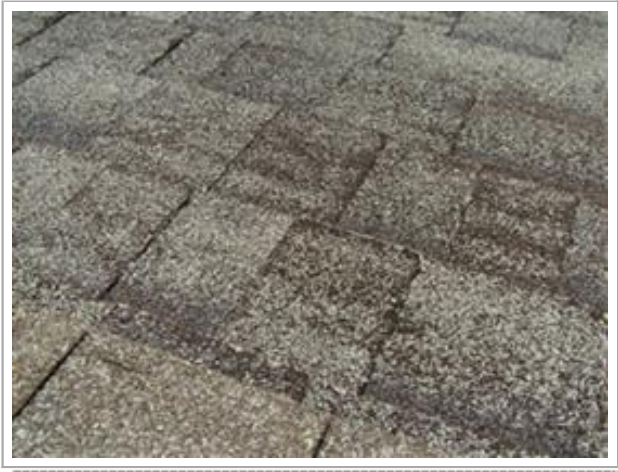
Figure Number 4

3. **ROOFING NEAR END OF EXPECTED LIFE.** I observed a roof covering that is nearing the end of its useful life. Roofing components that are in disrepair will eventually lead to roof leaks, delaying roof repairs or replacement is not a good idea as the leaks that result from deferred roof maintenance often lead to greater expense and damage to interiors. (See Figure #4)

1. ROOFING NEAR END OF EXPECTED LIFE. I observed a roof covering that is nearing the end of its useful life. Roofing components that are in disrepair will eventually lead to roof leaks, delaying roof repairs or replacement is not a good idea as the leaks that result from deferred roof maintenance often lead to greater expense and damage to interiors. (See Figure #4)
